# Metalith H<sub>2</sub>O™ Summary of Laboratory Testing

*By Don Ward, ERDC-CHL, April 10, 2008*

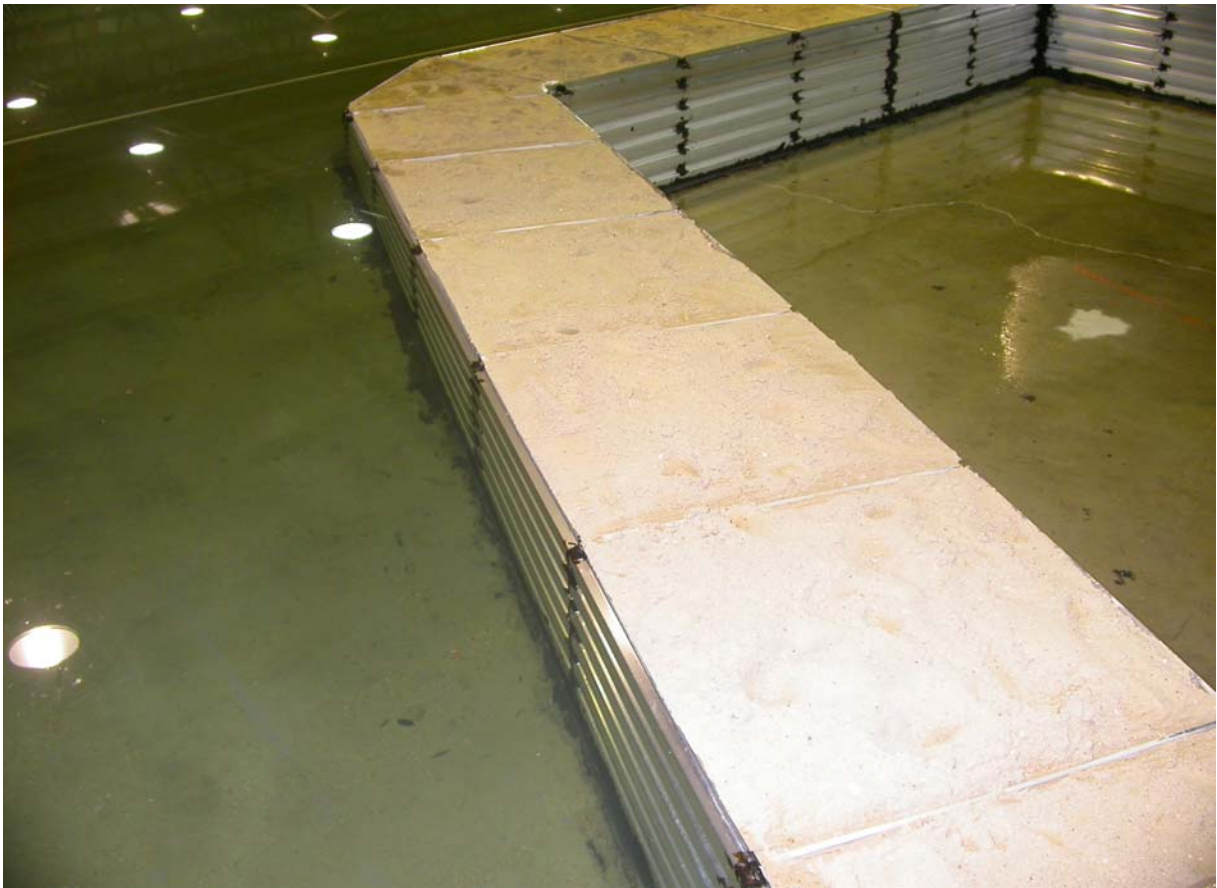
The Metalith H<sub>2</sub>O™ flood fighting barrier is manufactured by Infrastructure Defense Technology, LLC (IDT). The barrier is constructed of standard corrugated aluminum sheet panels used for siding and roofing. The panels are modified to fit together with pins to form a series of boxes which are then filled with sand or other material (Figure 1).

**Figure 1. The Metalith H<sub>2</sub>O™ flood fighting barrier.**
